**AES PUERTO RICO, L.P.
Guayama, Puerto Rico**

June 19, 2014 NPDES Enforcement Case Support Inspection Briefing

**José A. Rivera, BSCE
Regional Storm Water Specialist
Caribbean Environmental Protection Division**

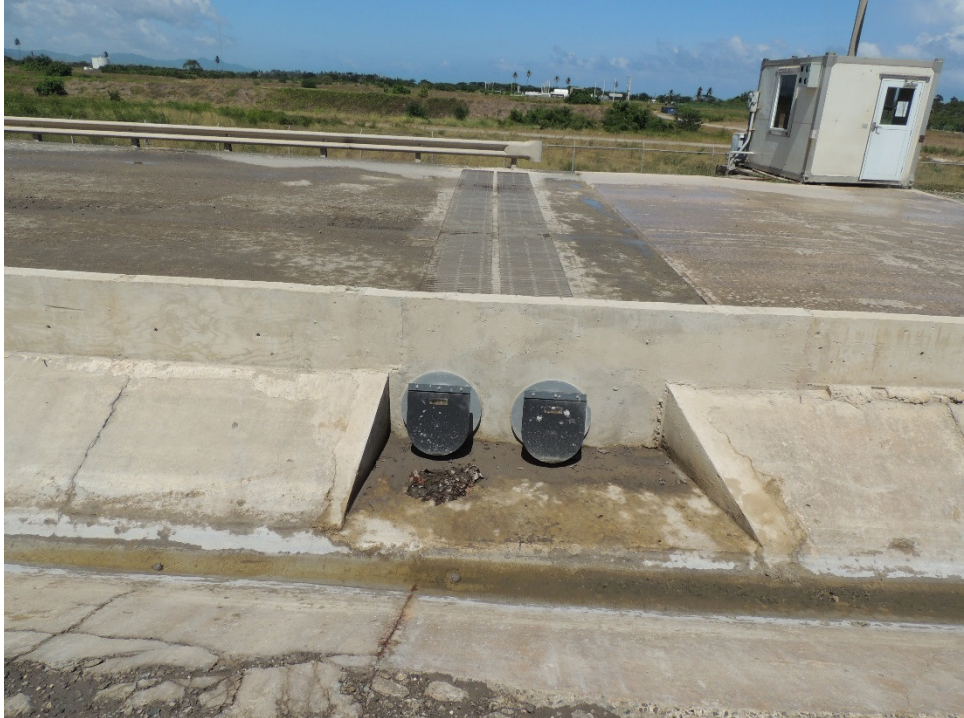
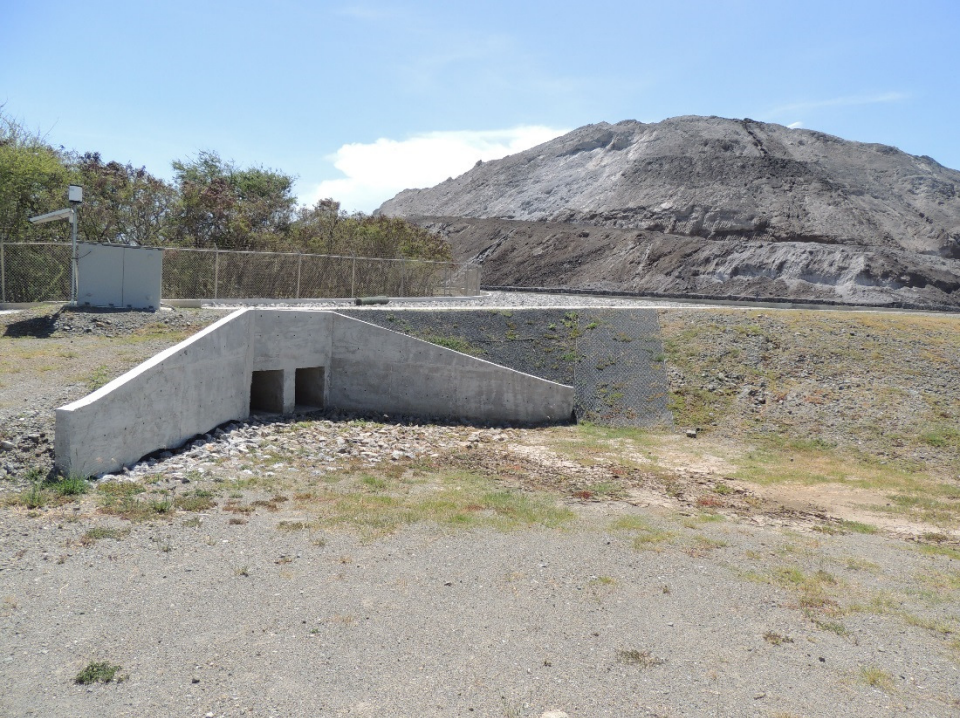
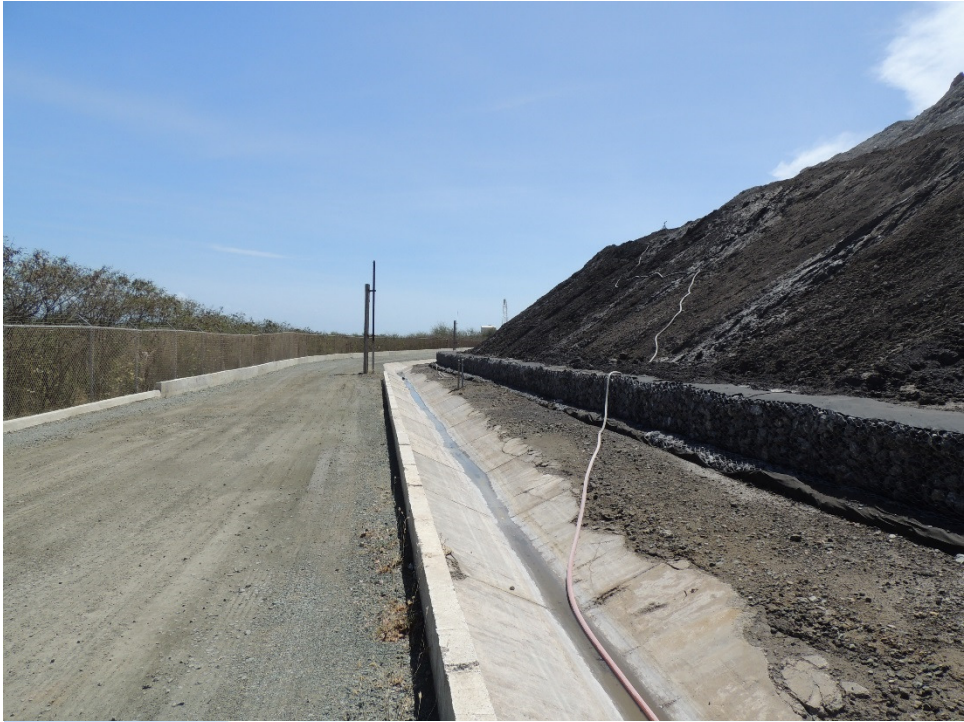
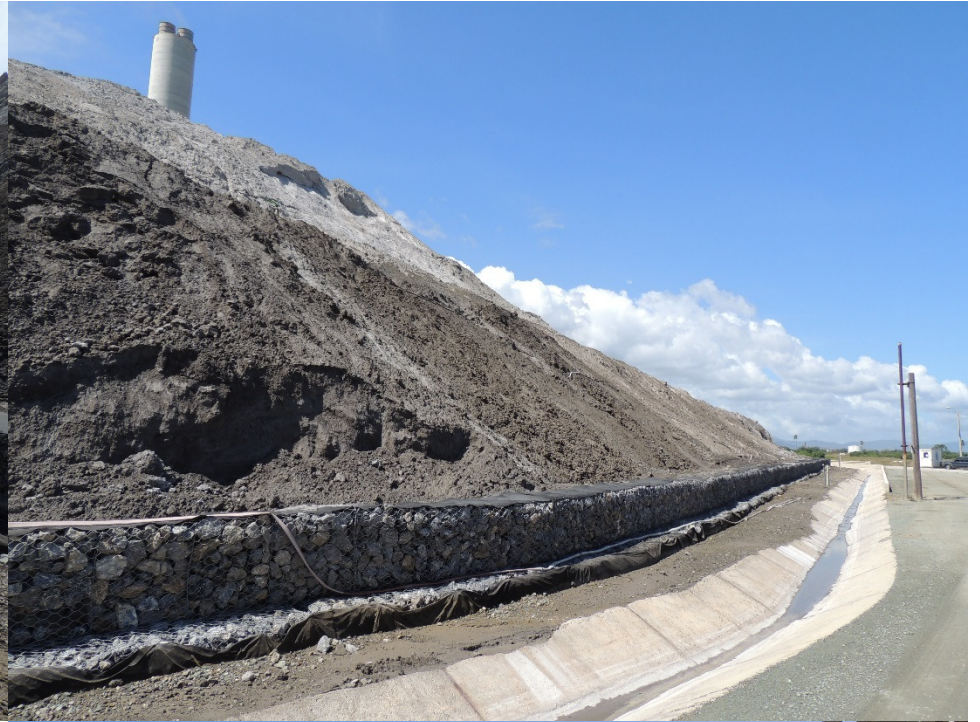
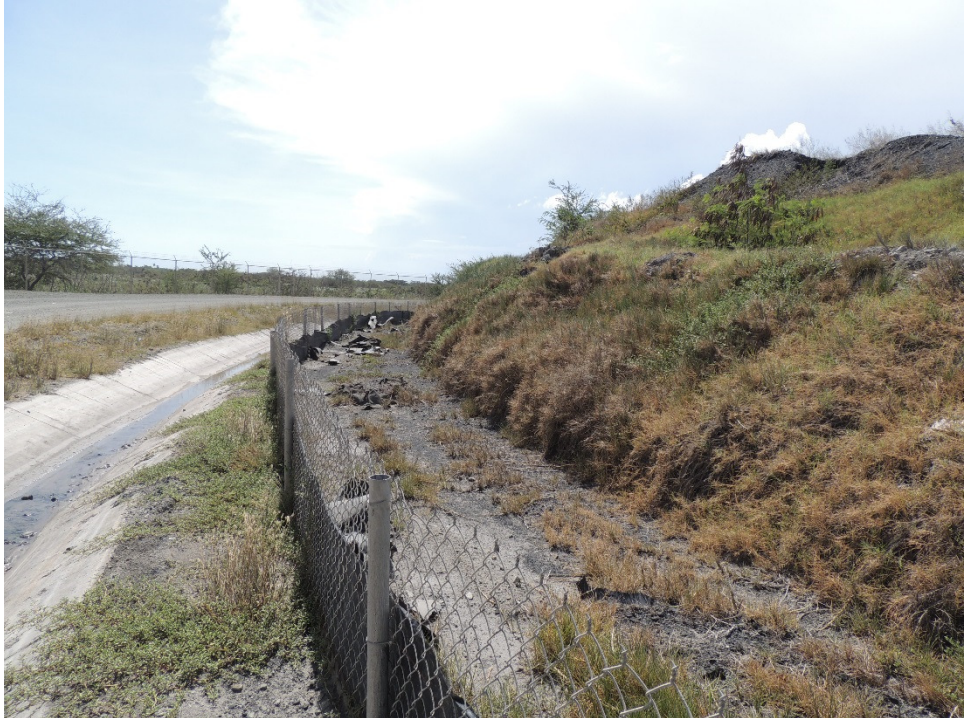
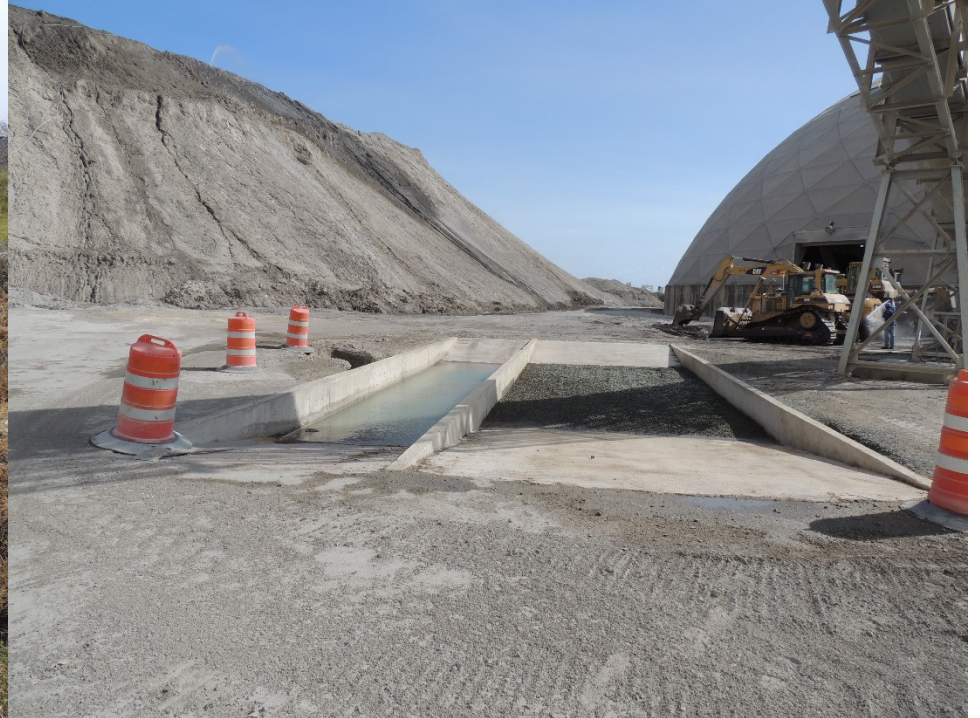
- Adequate Structural BMPs constructed/installed to segregate ash/coal/limestone from other industrial areas:
 - Re-pavement and re-grading
 - Low wall construction at several areas
 - Secondary containment
 - Gabions installation for erosion control
 - Relocation of Outfall 002
 - Segregation of stormwater from process wastewater
